Windstorm Mitigation Report (OIR-B1-1802)

The Gardens Of Forest Lakes Condominium Association, Inc.

129 Camphor Cir, Units A-H

As of 9/19/2023 | FPAT File# MUD2320834

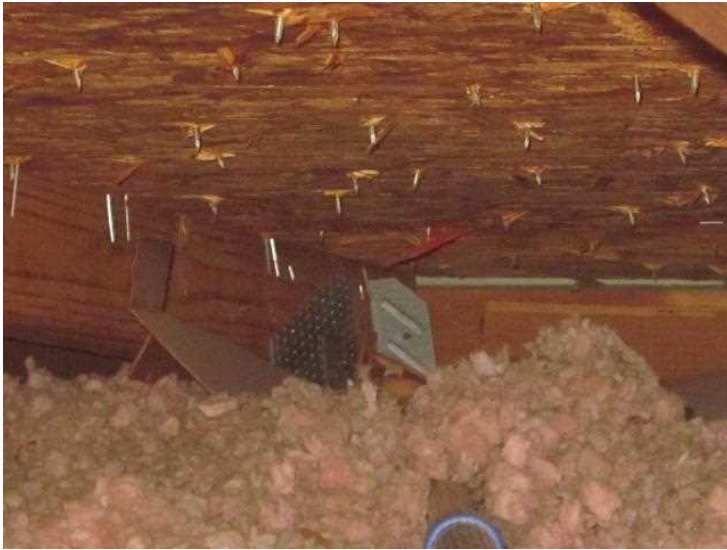
Roof Construction

- 3. Roof Deck Attachment:** **Level C**
Comments: Inspection verified 7/16" OSB roof deck attached with 8d nails at a minimum 6" on the edge & 6" in the field.

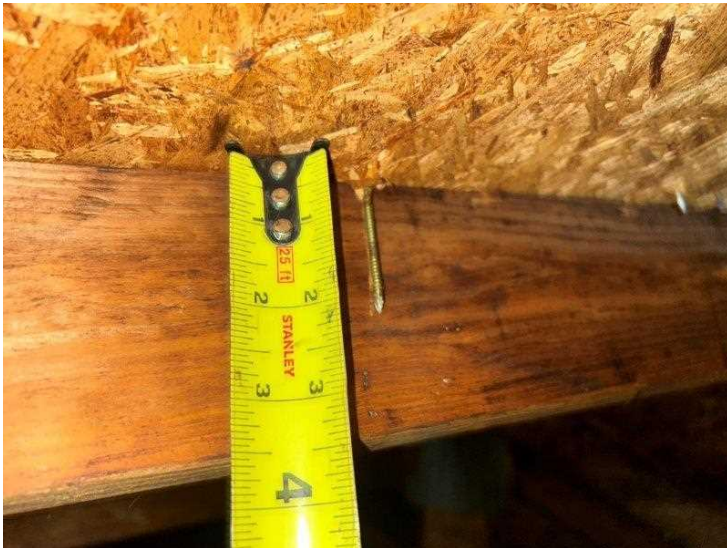
Roof Construction

- 4. Roof to Wall Attachment:** **Clips**
Comments: Inspection verified hurricane clips fastened with a minimum of three nails.
- 5. Roof Geometry:** **Hip Roof**
Comments: Inspection verified a hip roof shape.

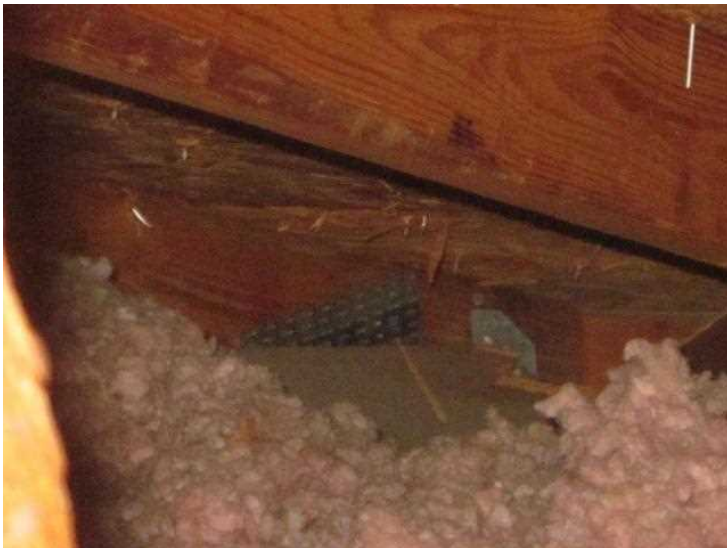
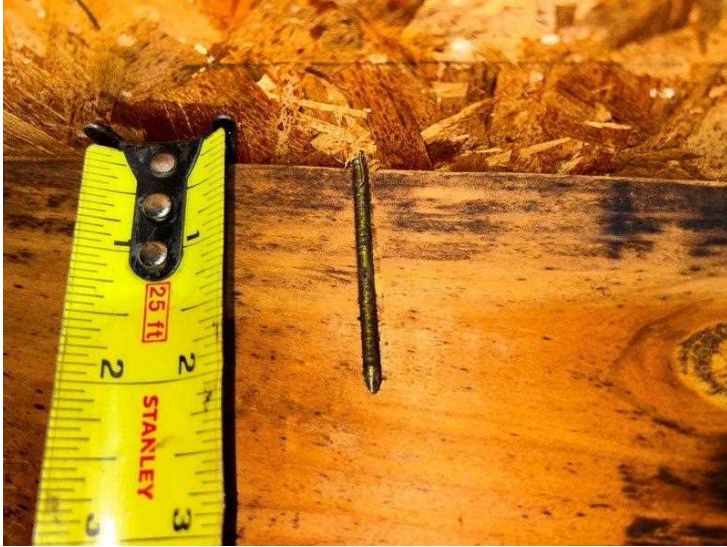
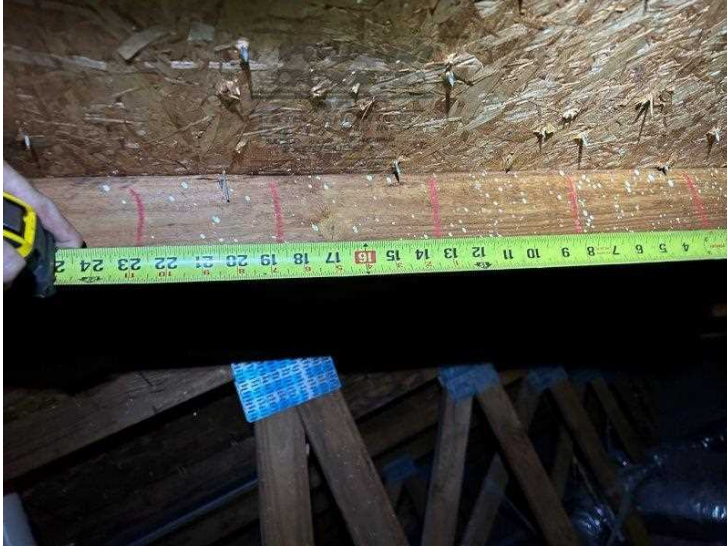
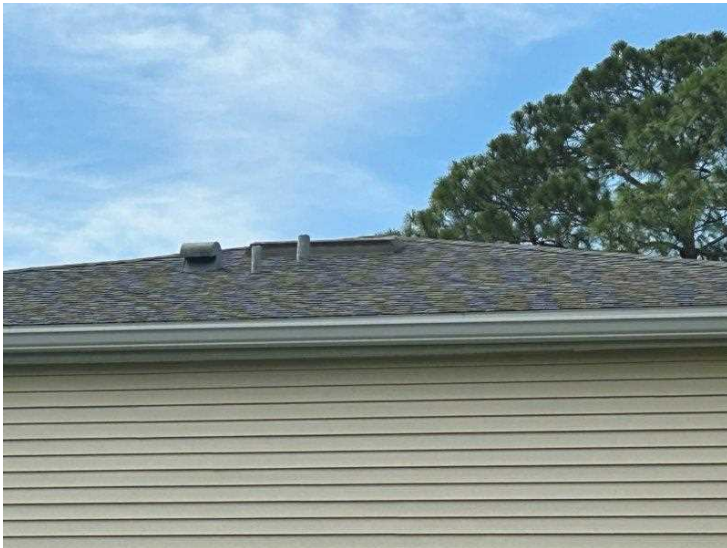
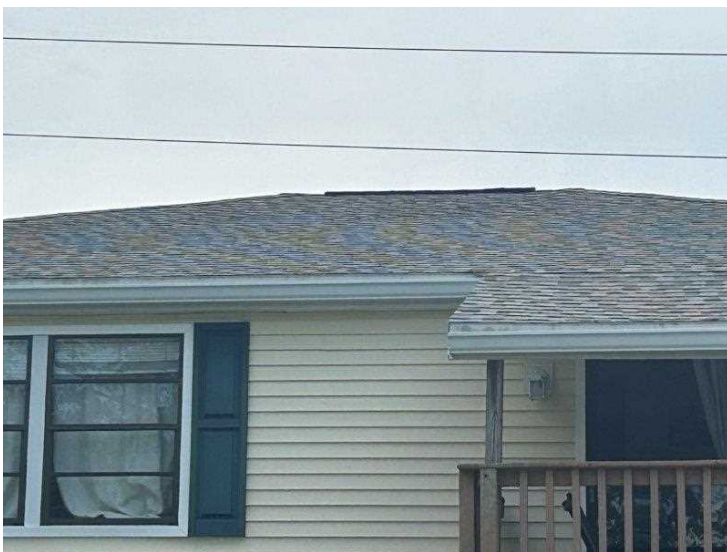
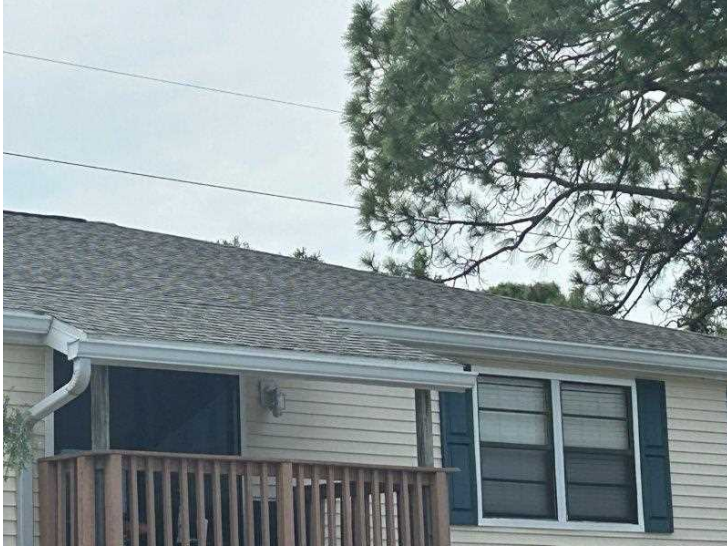
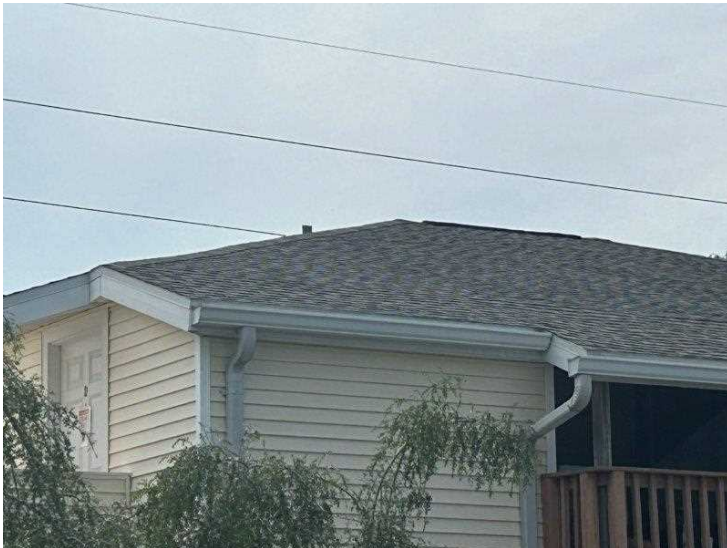
Roof Construction

- 4. Roof to Wall Attachment:** **Clips**
Comments: Inspection verified hurricane clips fastened with a minimum of three nails.
- 5. Roof Geometry:** **Hip Roof**
Comments: Inspection verified a hip roof shape.

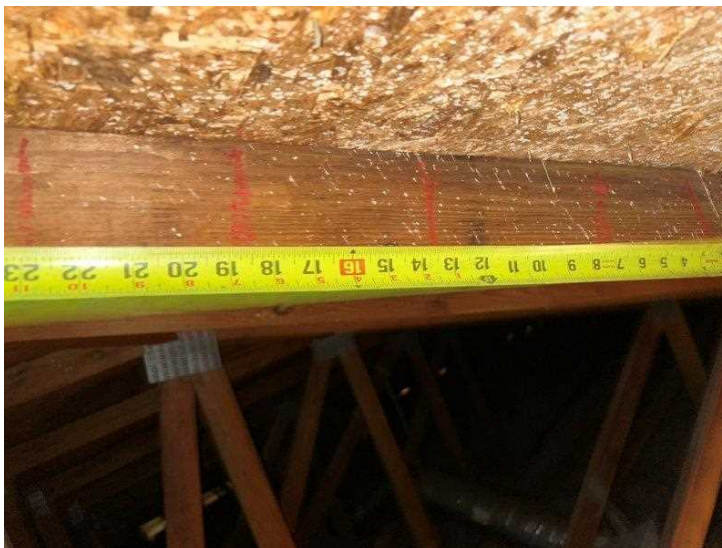
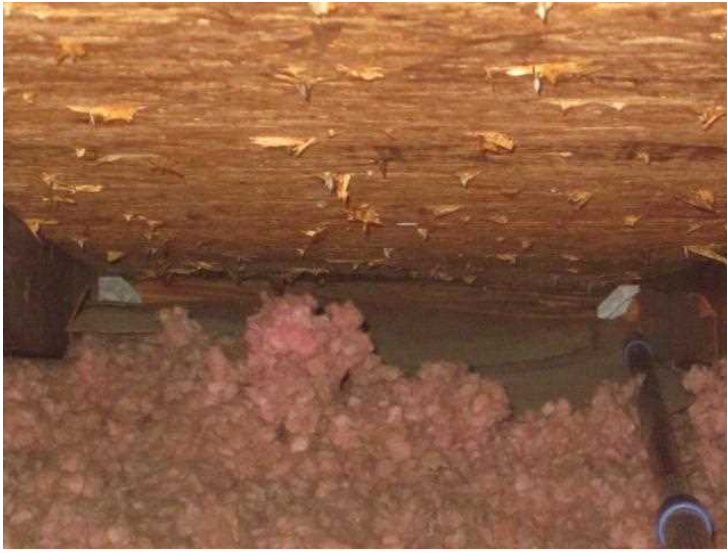
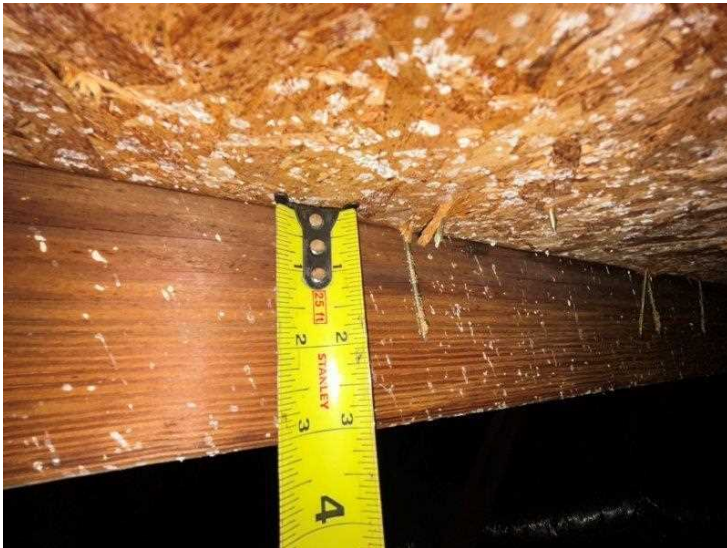
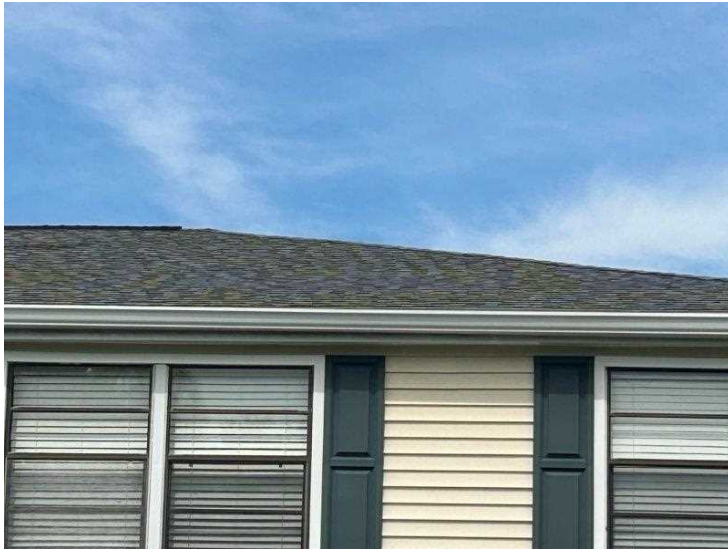
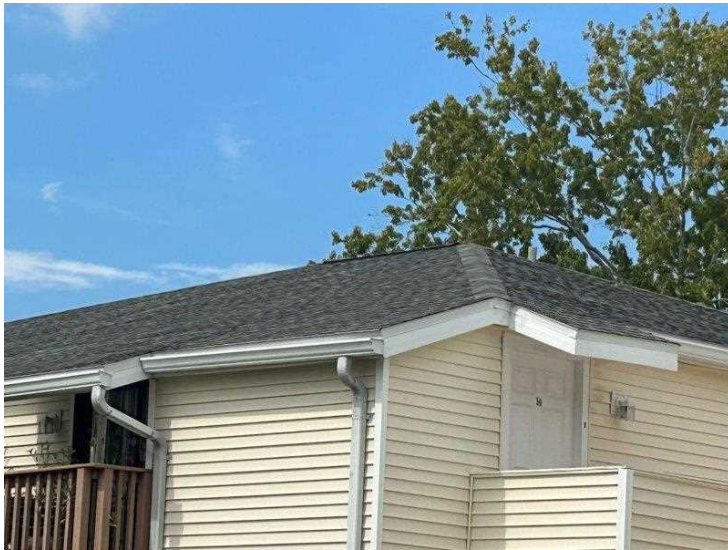
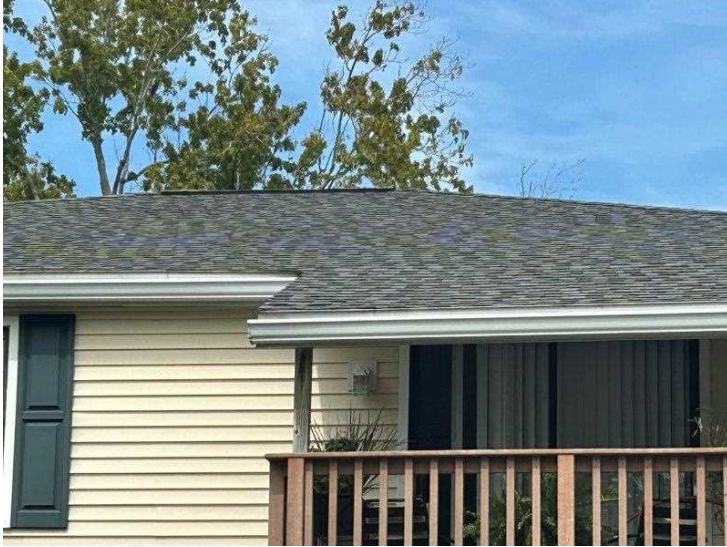
Roof Construction

- 4. Roof to Wall Attachment:** **Clips**
Comments: Inspection verified hurricane clips fastened with a minimum of three nails.
- 5. Roof Geometry:** **Hip Roof**
Comments: Inspection verified a hip roof shape.

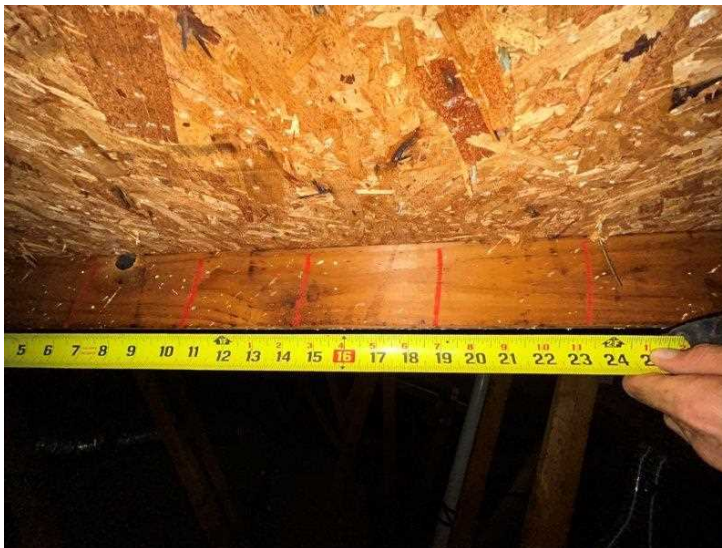
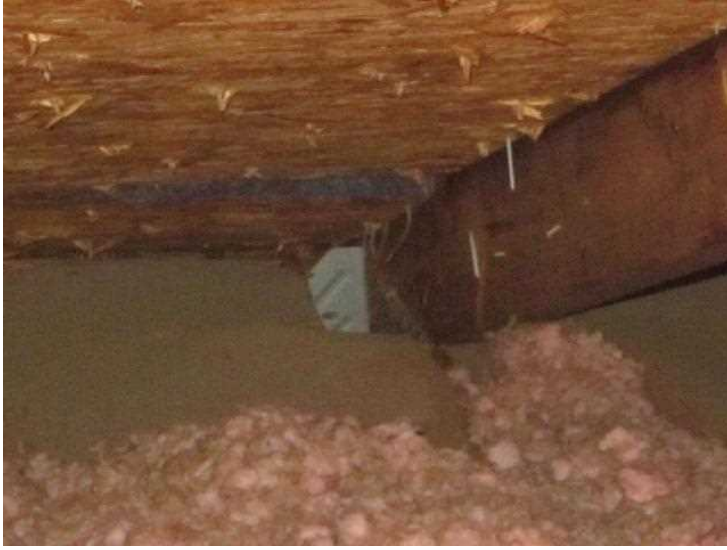
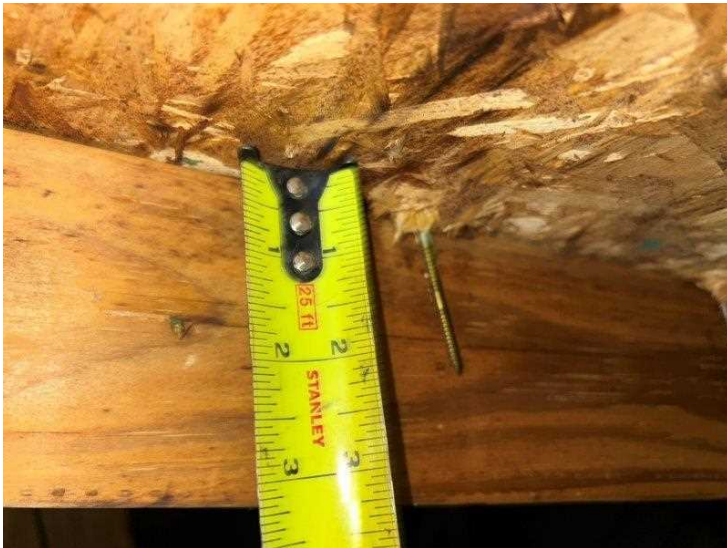
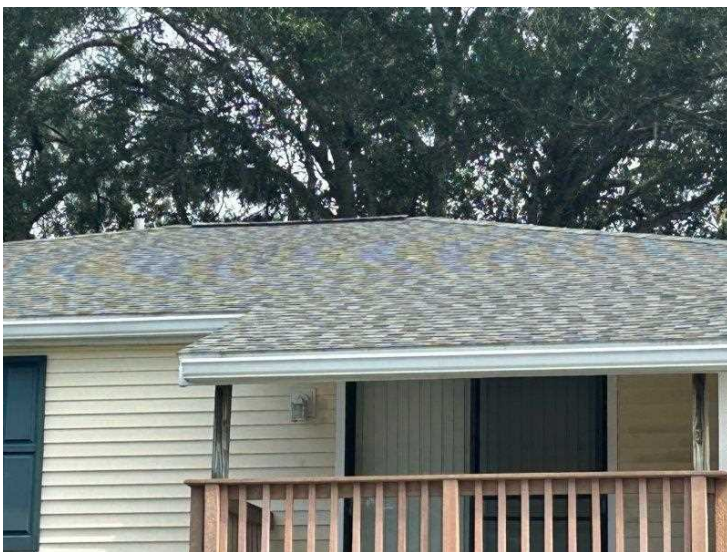
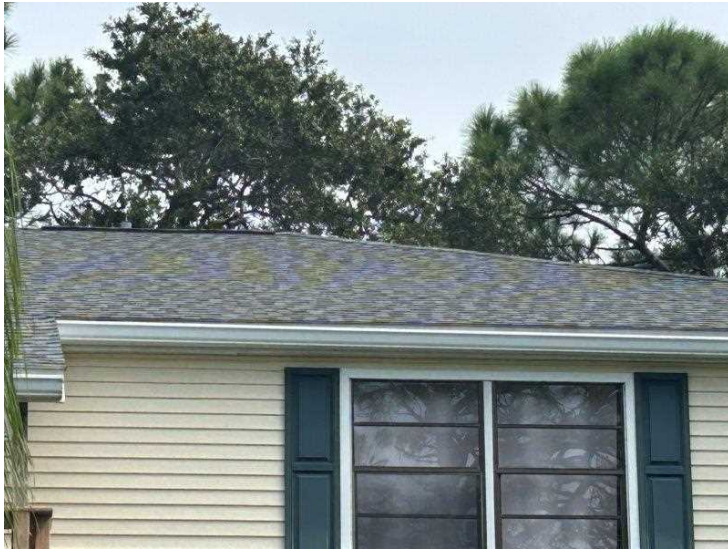
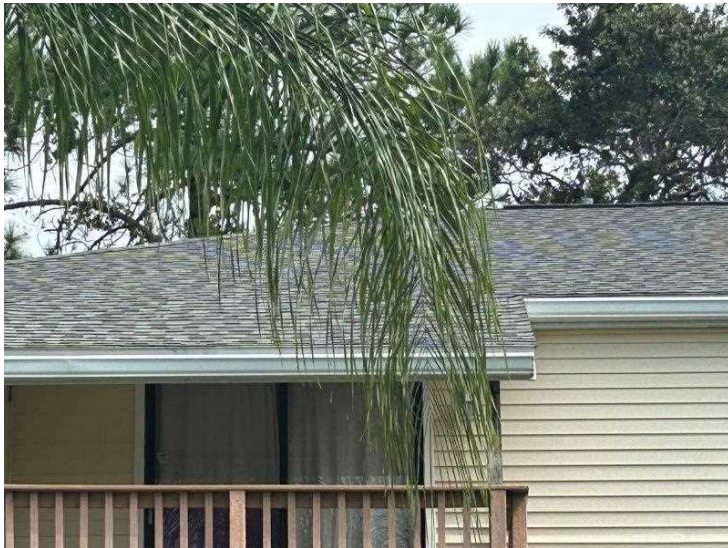
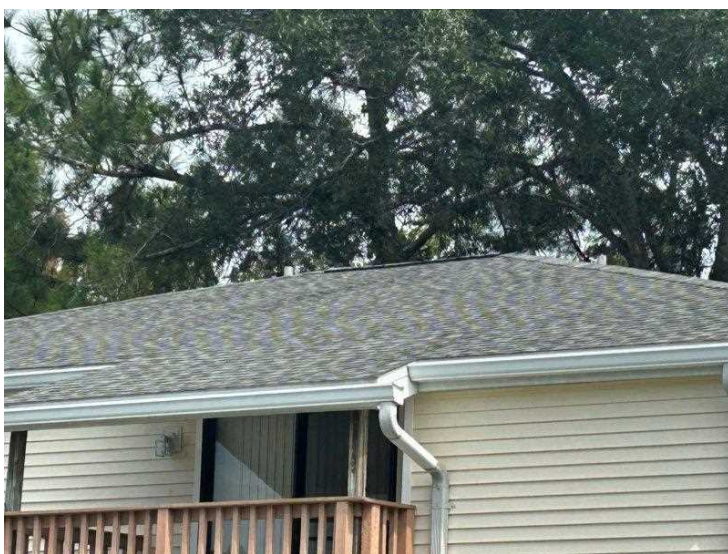
Roof Construction

- 4. Roof to Wall Attachment:** **Clips**
Comments: Inspection verified hurricane clips fastened with a minimum of three nails.
- 5. Roof Geometry:** **Hip Roof**
Comments: Inspection verified a hip roof shape.

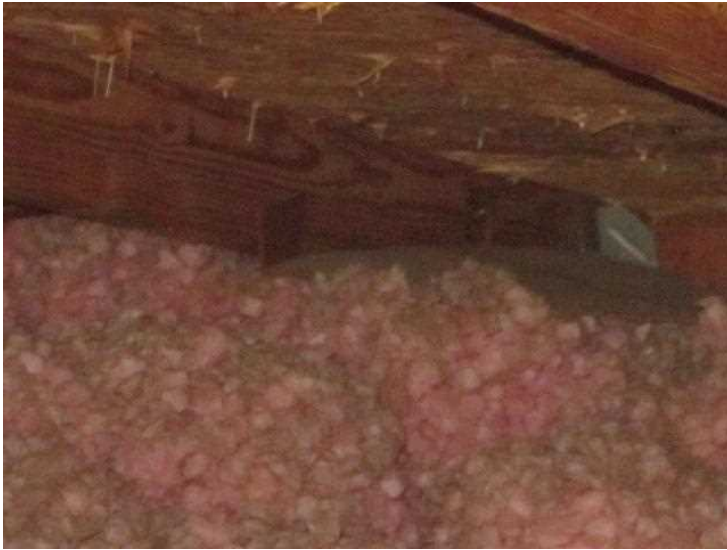
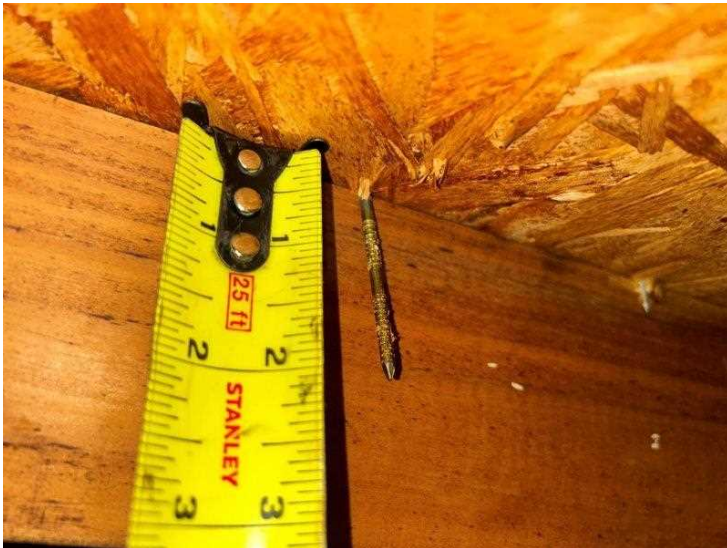
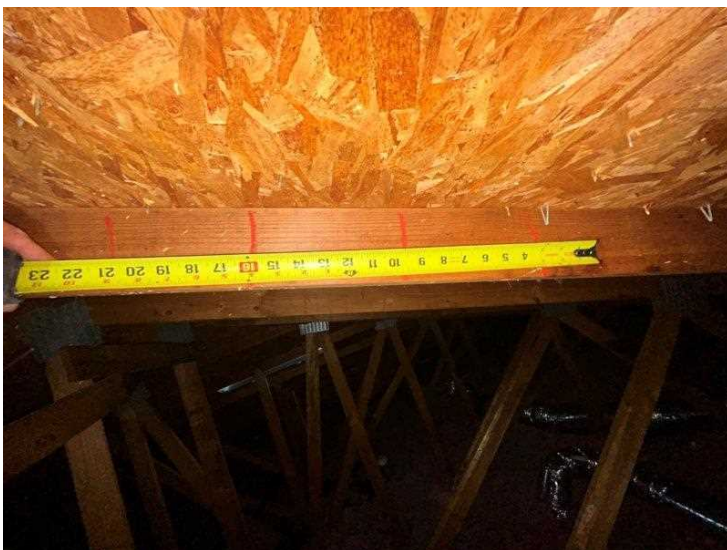
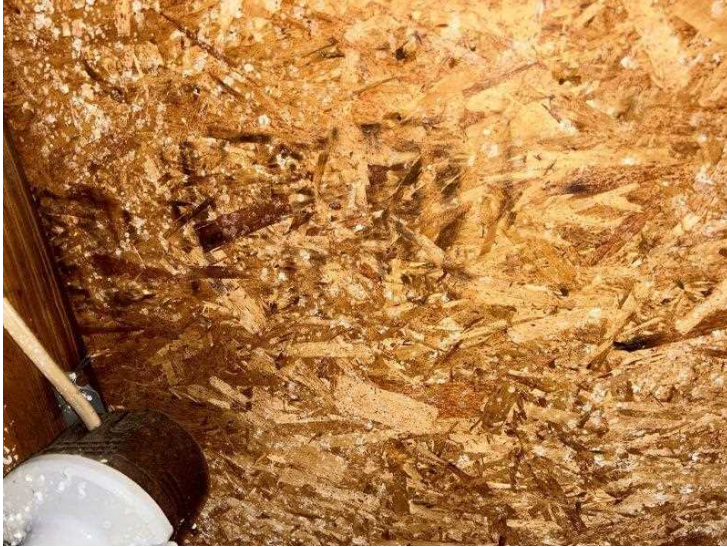
Roof Construction

- 4. Roof to Wall Attachment:** **Clips**
Comments: Inspection verified hurricane clips fastened with a minimum of three nails.
- 5. Roof Geometry:** **Hip Roof**
Comments: Inspection verified a hip roof shape.
