COMMERCIAL WINDSTORM MITIGATION INSPECTION REPORT

The Gardens Of Forest Lake Condominium Association, Inc.

As of 7/9/2013

(20) 2-Story Residential Buildings

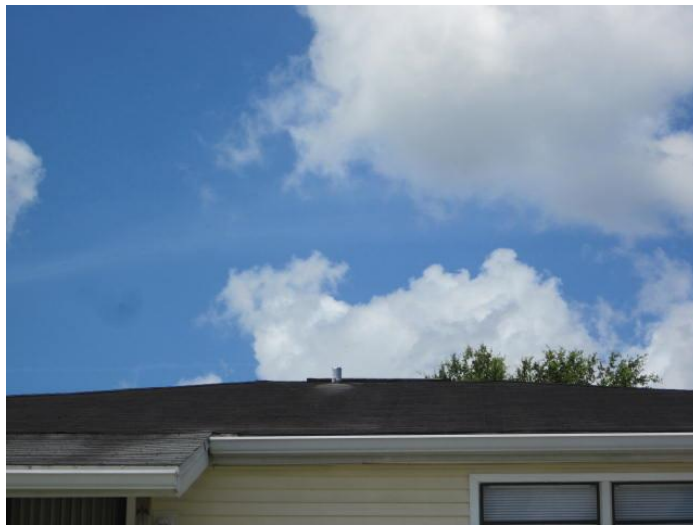
Roof Covering

Comments: | No roof coverings meet the minimum requirements
The roof covering is not original; however, no permit information was found with the local Building Department. This roof was verified as not meeting the requirements outlined on the OIR 1802 form. |

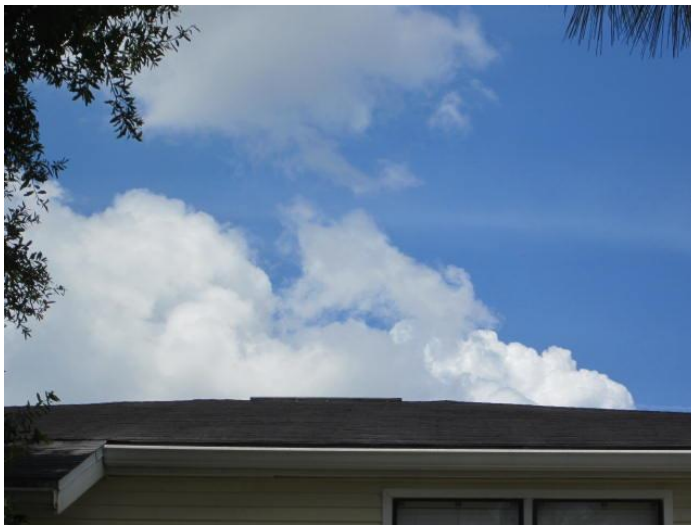
Roof Covering

Comments: | No roof coverings meet the minimum requirements
The roof covering was replaced in 1993. The roof permit was confirmed and the permit number is 9328. This roof was verified as not meeting the building code requirements outlined on the mitigation affidavit. |

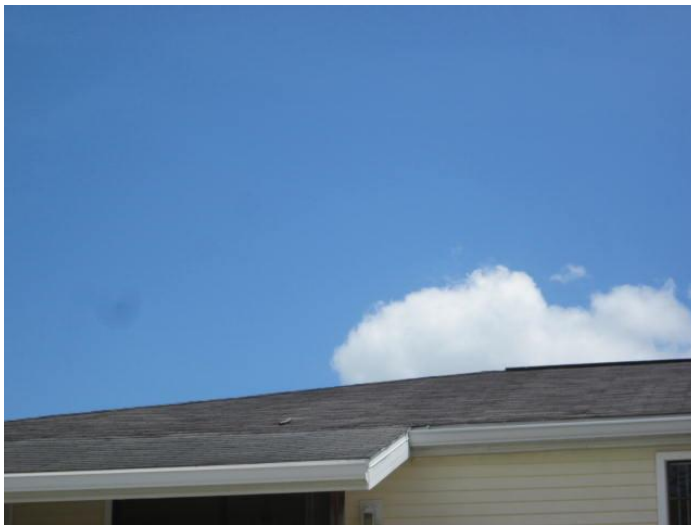
Roof Covering

Comments: | FBC Equivalent
The roof covering was replaced in 2003. The roof permit was confirmed and the permit number is 030629. This roof was verified as meeting the building code requirements outlined on the mitigation affidavit. |

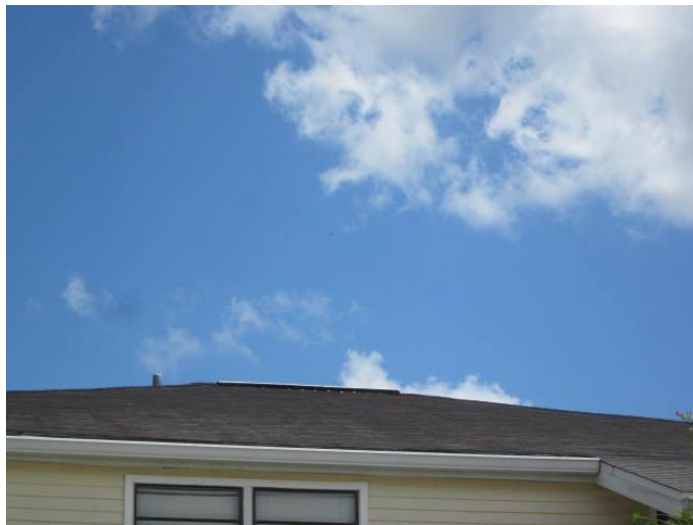
Roof Covering

Comments: | No roof coverings meet the minimum requirements
The roof covering was replaced in 2000. The roof permit was confirmed and the permit number is 000865. This roof was verified as not meeting the requirements outlined on the OIR 1802 form. |

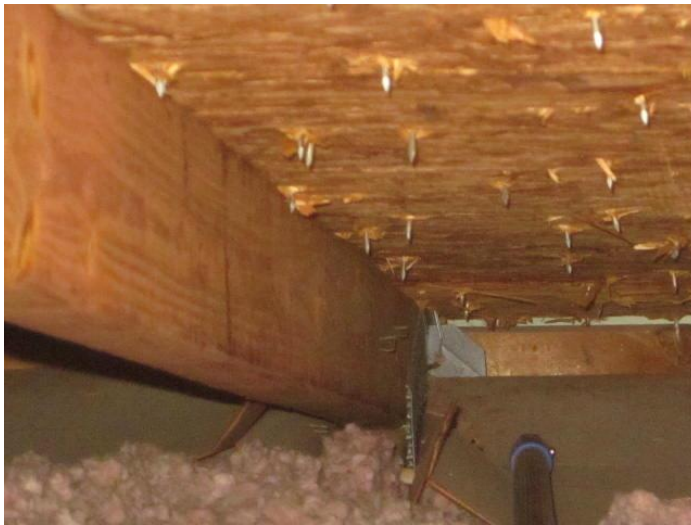
Roof to Wall Attachment

4. **Roof to Wall Attachment:** **Clips**
Comments: Inspection verified hurricane clips fastened with a minimum of three nails.
5. **Roof Geometry:** **Hip Roof**
Comments: Inspection verified a hip roof shape.

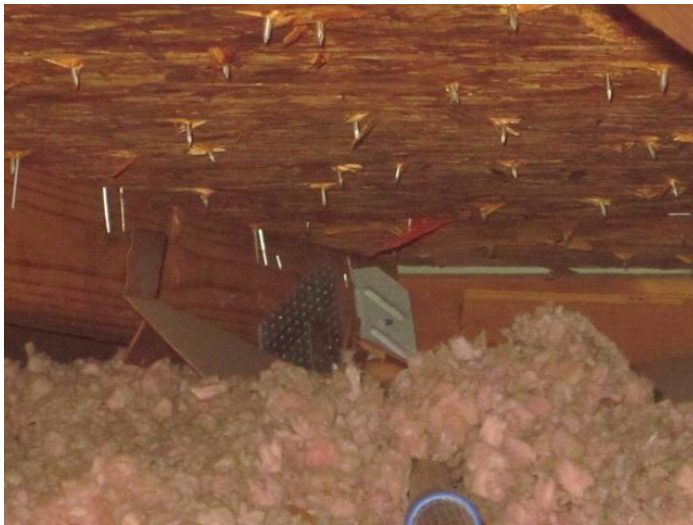
Roof to Wall Attachment

4. **Roof to Wall Attachment:** **Clips**
Comments: Inspection verified hurricane clips fastened with a minimum of three nails.
5. **Roof Geometry:** **Hip Roof**
Comments: Inspection verified a hip roof shape.

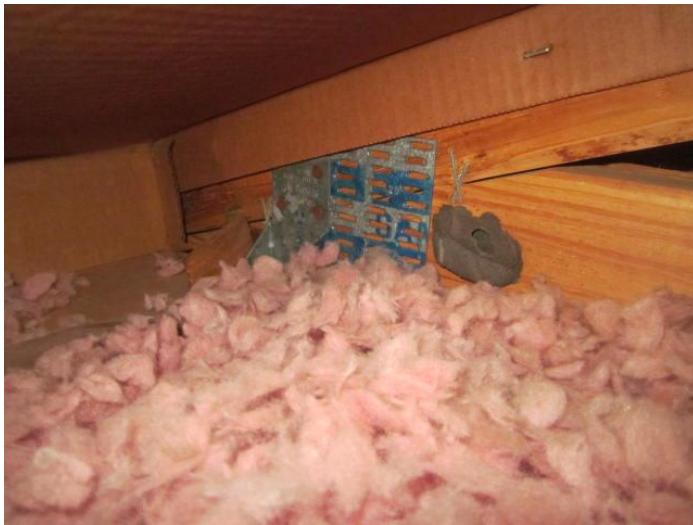
Roof to Wall Attachment

4. **Roof to Wall Attachment:** **Clips**
Comments: Inspection verified hurricane clips fastened with a minimum of three nails.
5. **Roof Geometry:** **Hip Roof**
Comments: Inspection verified a hip roof shape.
